DRON & DICKSON

CABLE REPLACEMENT

Case Study

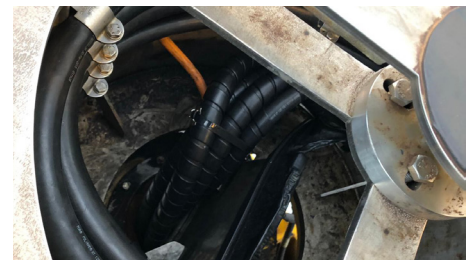
Internals of the Drag Chain - After

All existing glands, cables and associated materials were removed before installing new cables correctly within the hydraracker unit.

- Highly trained personnel with CompEx and IRATA skills were deployed to complete the project on time and within budget
- Dron & Dickson supplied all materials for the project including cabling, cable glands, cable markers/consumables and containment
- Ten multicore cables were removed, replaced, glanded, terminated, labelled, tested and commissioned
- Onshore engineering support was provided as standard

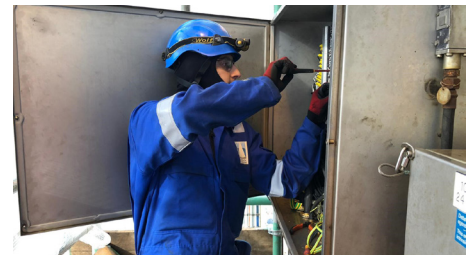
Technician Terminating Cables

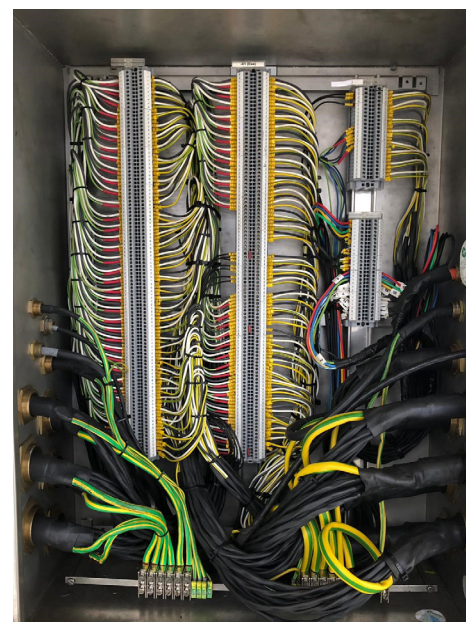
Marshalling Cabinet - After
