# DRON & DICKSON

## DISTRIBUTION BOARD REPLACEMENT

Case Study

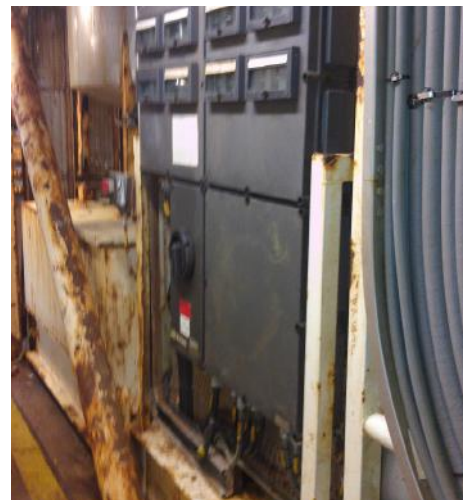
#### Before

An Operator had a requirement to update a distribution board on-board a North Sea asset. The existing board had been in use since 1991, had exceeded its reasonable working lifetime and was in poor physical condition. Failure of some major, now obsolete components that could not be replaced drove the decision for an upgrade to a suitable, modern, fit for purpose replacement.

The existing distribution board was isolated and all outgoing cables labelled and disconnected for removal. Small modifications were made to the existing framework then in conjunction with the clients rigging team, the new fully assembled distribution board was put in place. The new system was designed to 'plug and play' for minimal disruption and downtime.

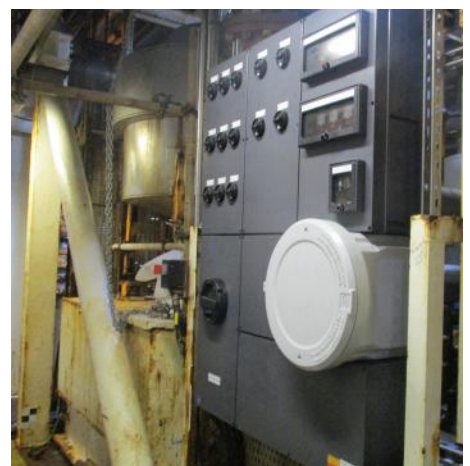
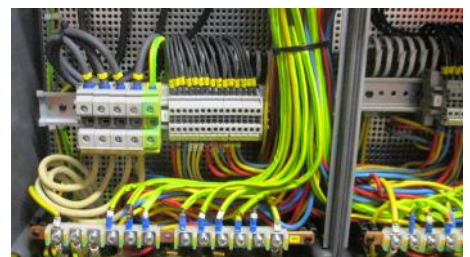
#### After

The project was completed within the client's TAR plan timeline and the new distribution board is fully commissioned, operable and compliant.

- Dron & Dickson Technicians then proceeded to re-gland, terminate, label, test and commission all outgoing cables
- Dron & Dickson supplied all materials for the project including the distribution board, cabling, cable glands, cable markers/consumables and containment
- Work pack and commissioning procedures were provided by the dedicated Onshore Engineering Support Team
