DRON & DICKSON

DROPPED OBJECTS

Case Study

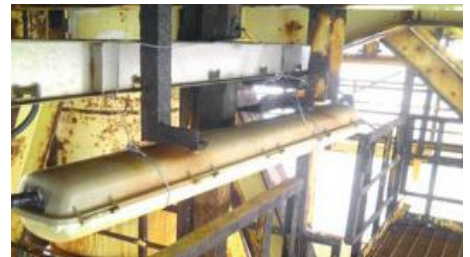
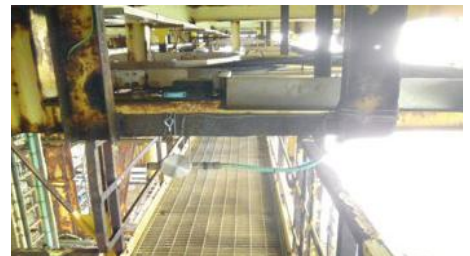
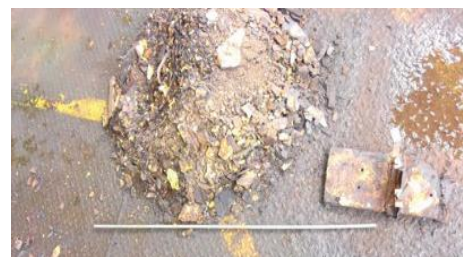
Over the course of the survey, huge amounts of scale and dropped objects were removed.

- Suitable plot plan and layout drawings were made available to ensure the work instruction covered all areas and to allow suitable red line mark-up of barriers and areas of concern
- Where appropriate, the use of secondary retention stainless steel wires were utilised as a means of making safe potential dropped objects
- Particular attention was taken in areas of high traffic (walkways) and included
 - Items over 7 Kilogrammes at a height of 2 + meters
 - Items over 3 Kilogrammes at a height of 4 + meters
 - Items with a single point of retention
 - Unistrut and tertiary steel supports
- Scale on structural steel was removed to deck level
- Loose redundant items such as tools, instruments and strops were removed to deck level
