DRON & DICKSON TRACE HEATING SYSTEM UPGRADE

Case Study

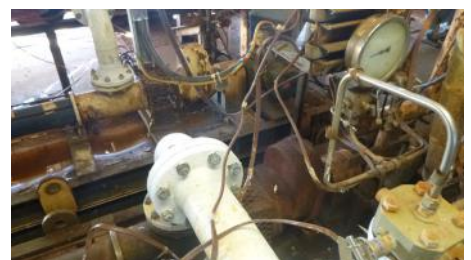
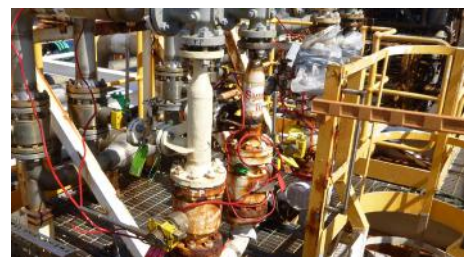
Before

A North Sea operator contacted Dron & Dickson with an urgent request for assistance following an unplanned outage due to major Corrosion Under Insulation (CUI) issues on an FPSO. The existing trace heating system was almost 20 years old. A speedy resolution was required to install a fully functional, compliant and fit-for-purpose system, limiting production downtime.

Dron & Dickson immediately mobilised a survey team who identified significant trace heating system issues. Based on the findings a strategy was devised in conjunction with the client with a focus on start-up critical lines (SUC) as well as other areas of concern including corroded junction boxes.

Over 3,000 meters of trace heating was surveyed, designed, installed and commissioned. All SUC lines, tapes and junction boxes were replaced. In advance of the winter months, the FPSO was successfully returned to production avoiding immeasurable financial and HSE implications.
